## SERVICE BULLETIN

**BULLETIN NO: AM-466-TLH**

**EQUIPMENT:** AMS-G1 Stereo Generator

**SUBJECT:** Pilot Crystal Circuit

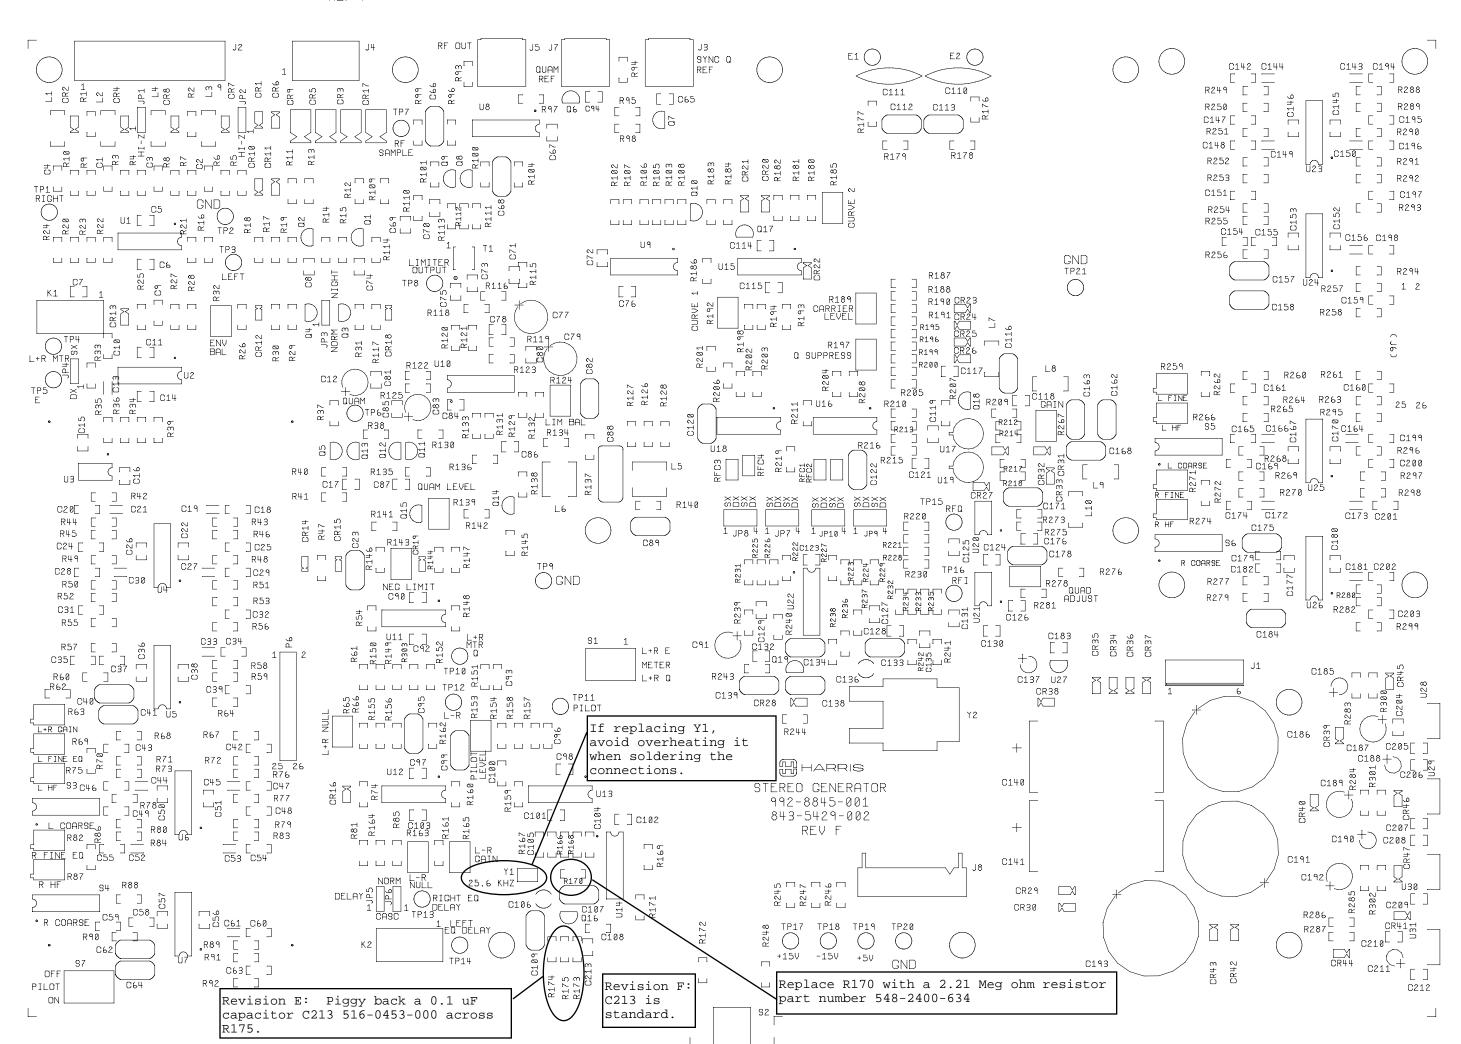
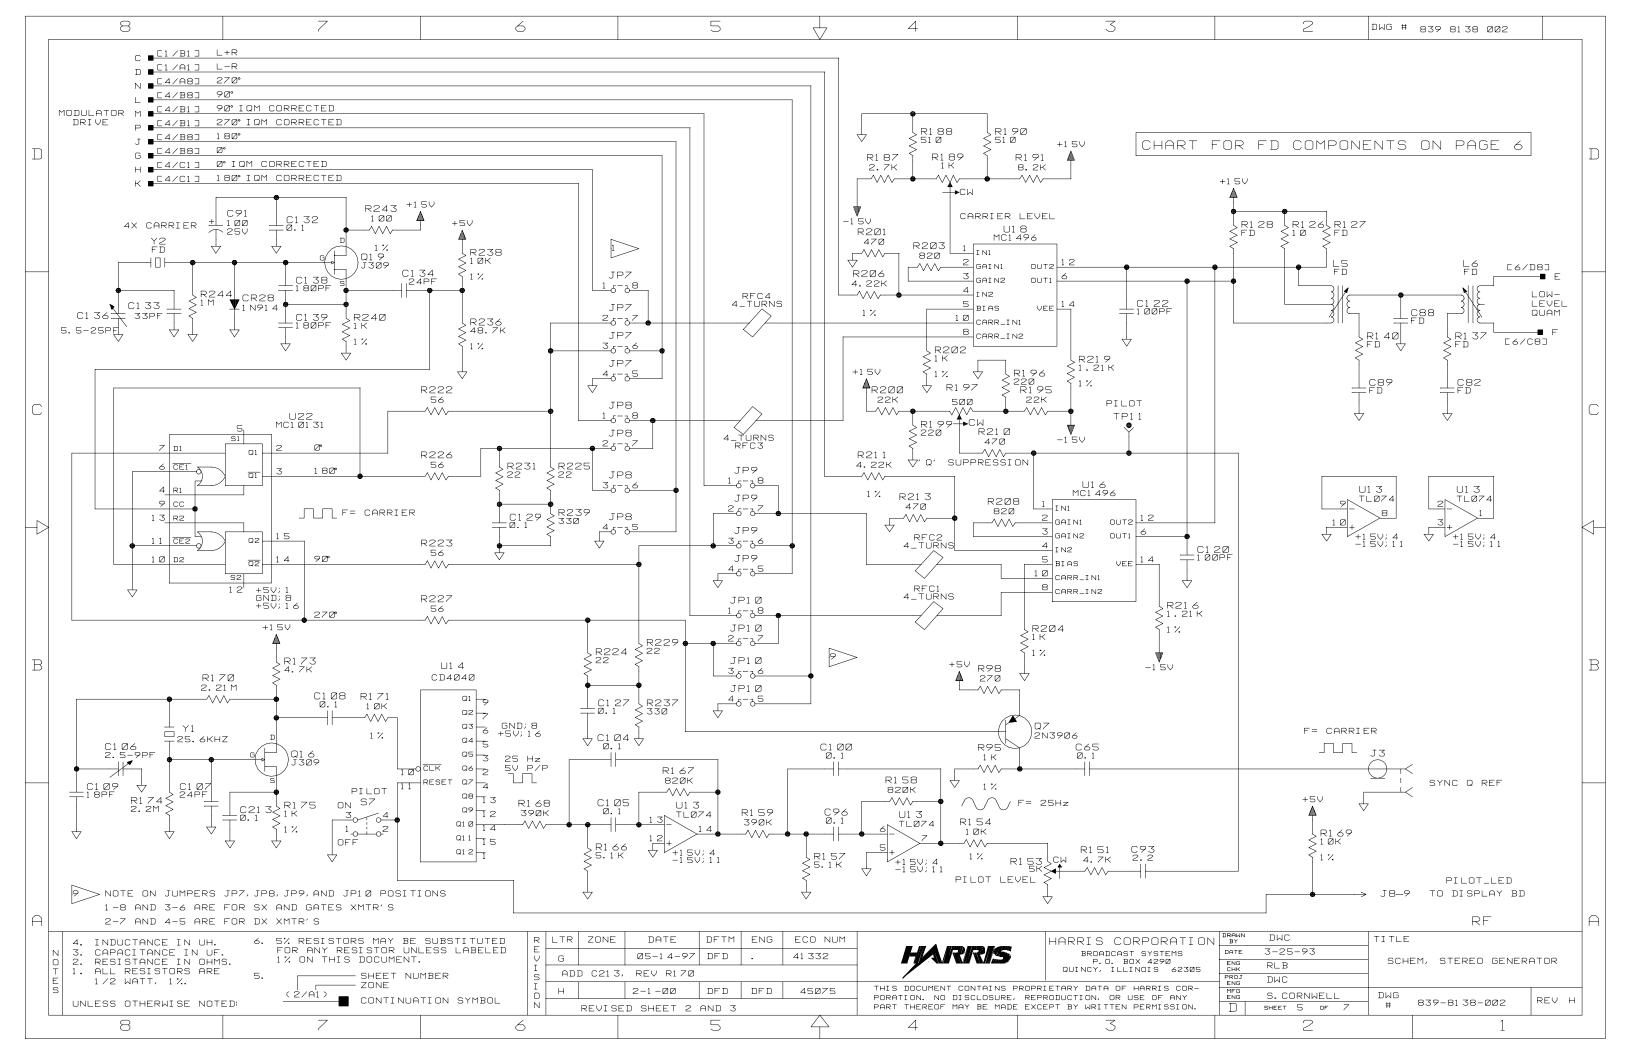
We have determined that the signal level within the Y1 pilot crystal circuit may be too high, leading to failure of the crystal and complete loss of the 25 Hz pilot.

- 1. Disconnect the AC power and any connections necessary to allow reasonable access to the top of the AMS-G1 Stereo Generator.
- Remove the top cover to gain access to the Stereo Generator board. See drawing.
- 3. It is possible to make the changes without removing the circuit board. However, if you prefer to remove the board so that you have access to the bottom of the board, please use the following steps:
  - a. Remove the plastic safety cover from the PDM Sample connector. You will need a 5/16" nut driver for this.
  - b. Unsolder the wires from the PDM Sample connector.

- c. Remove the 6 screws which fasten the rear panel in place.
- d. Unplug J1 and J8.
- e. Remove the mounting screws from the board (Qty 14), and screws which fasten the aluminum heat sink in place on the right hand side (Qty 2).
- f. Lift the board so that it clears the power transformer, and slide it out the rear of the chassis.
- 4. A new crystal is being provided in case yours has failed. It is otherwise not necessary to replace it. Note that if you need to replace the crystal, take care to avoid overheating it while soldering the connections.
- 5. Remove the existing R170, and replace it with the enclosed 2.21 Meg ohm resistor.
- 6. Add a 0.1 uf capacitor, C213, across R175.
- 7. This completes the modification. Reinstall the hardware and connections removed in the preceding steps.
